PROJECT: PL23-0015 - Determination of Significance for a property identified on the City's Historic Resource Inventory

LOCATION: 856 West Grand Avenue

856 W GRAND AVE. ESCONDIDO, CA 92025 HISTORICAL BUILDING ASSESSMENT

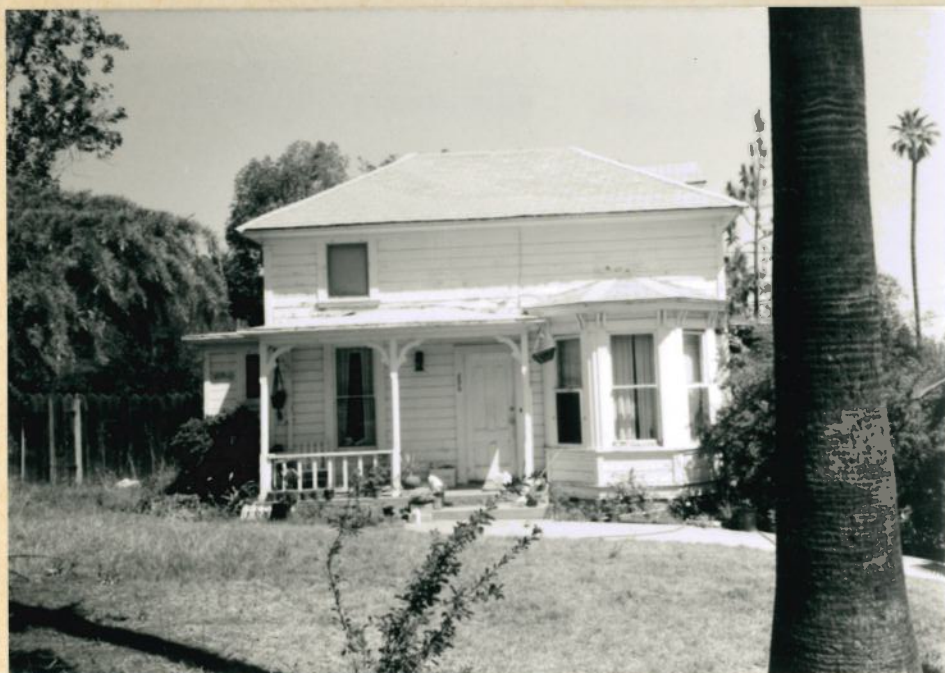
A large slanted bay window dominates the front (south) facade of this well-maintained Italianate cottage. Pairs of carved brackets decorate the cornice of the bay which has three tall, narrow double-hung windows. A truncated hip roof with an enclosed cornice tops the shiplap-sided house. Vertical boards trim the corners. A shed-style roof shelters the front porch and is supported by carved wood posts with carved brackets. A plain balustrade is used on the southwest corner of the porch. The four-paneled converted cross front door appears to be original and is flanked by a double-hung wood window. A small casement window is located above this. A dormer to the east side has twin windows extending from the gabled dormer roof to the top of the first story. A wing on the west side has an almost flat roof, enclosed cornice, and double-hung windows and is possibly an early addition.

The architectural style is: Italianate

The condition is: good

The related features are: two large fir trees; newer carport and tin shed on lower level

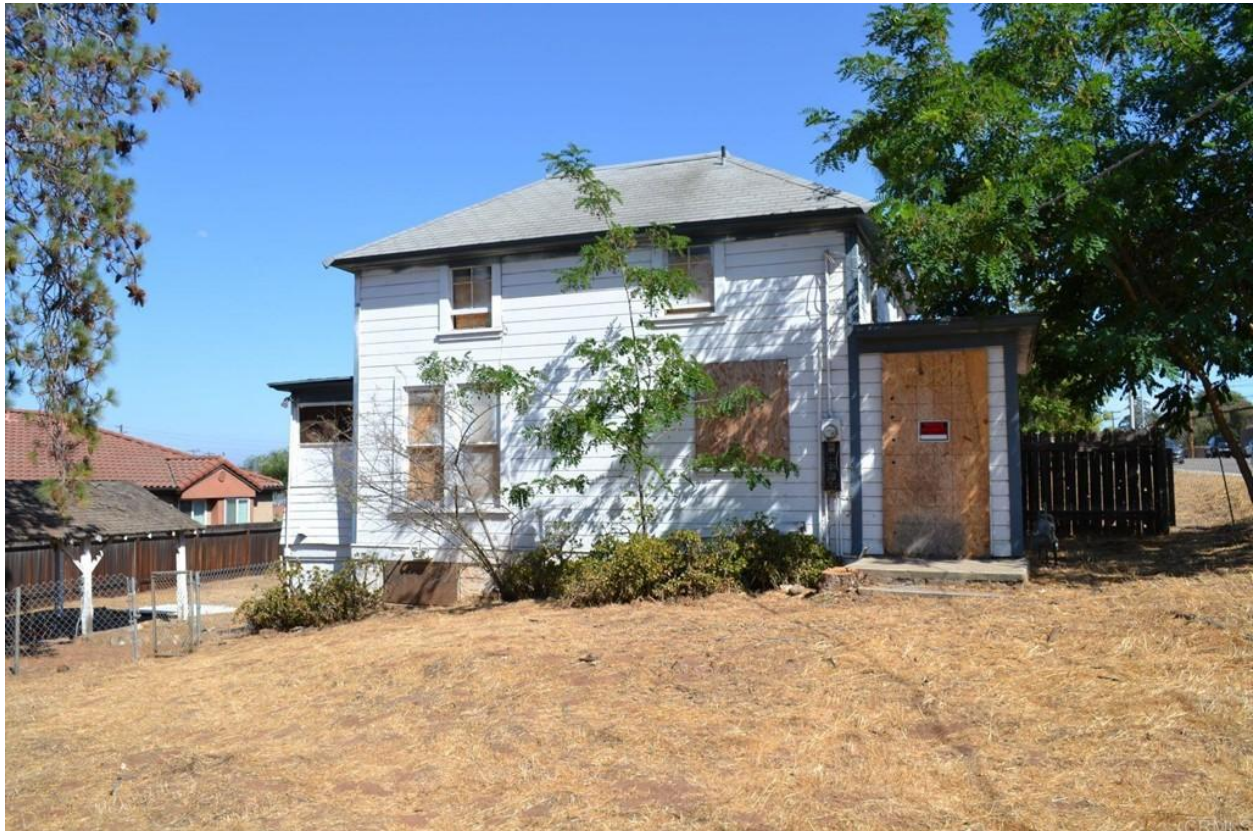
Rear Elevation:

All windows in the structure have been broken; excessive dry rot to window frames and sills has occurred as a result. Original entry doors are missing.

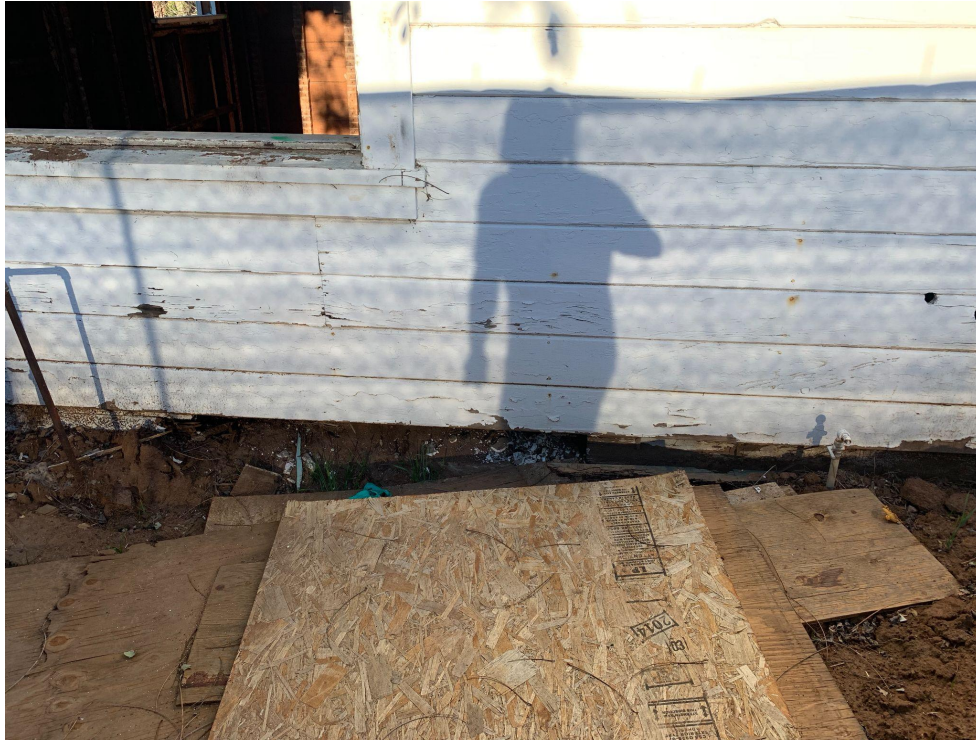
Figure 3. Exterior View (Existing wood on grade foundation has completely rotted away; this wall has no structural support.)

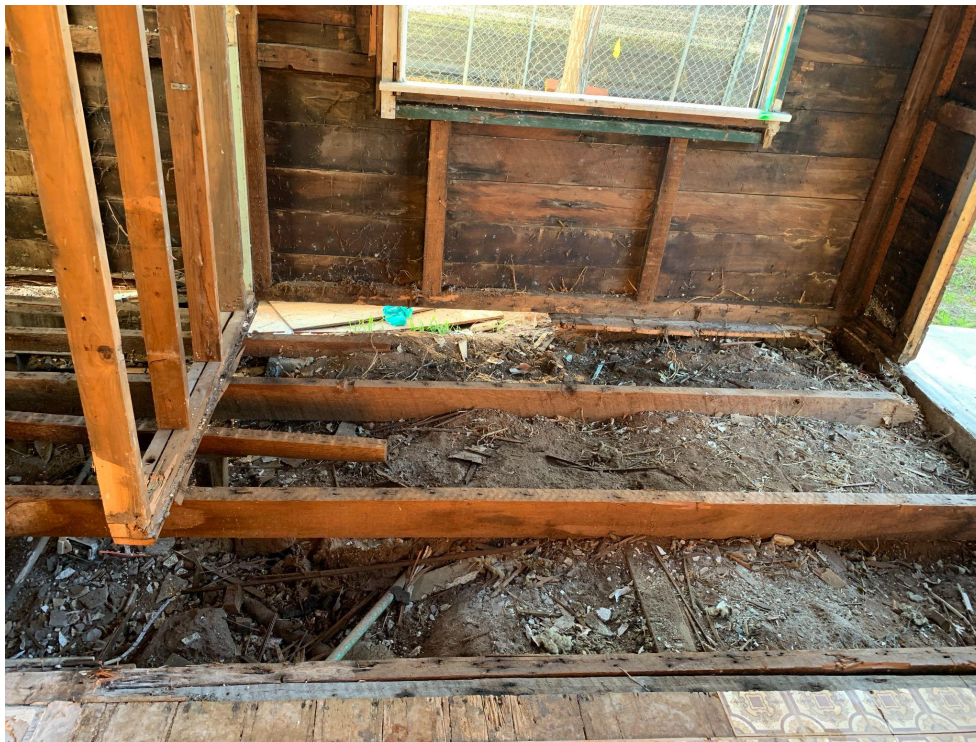
Figure 4. Interior View (no support below exterior wall. Floor joists are unsupported and sitting directly on soil.)

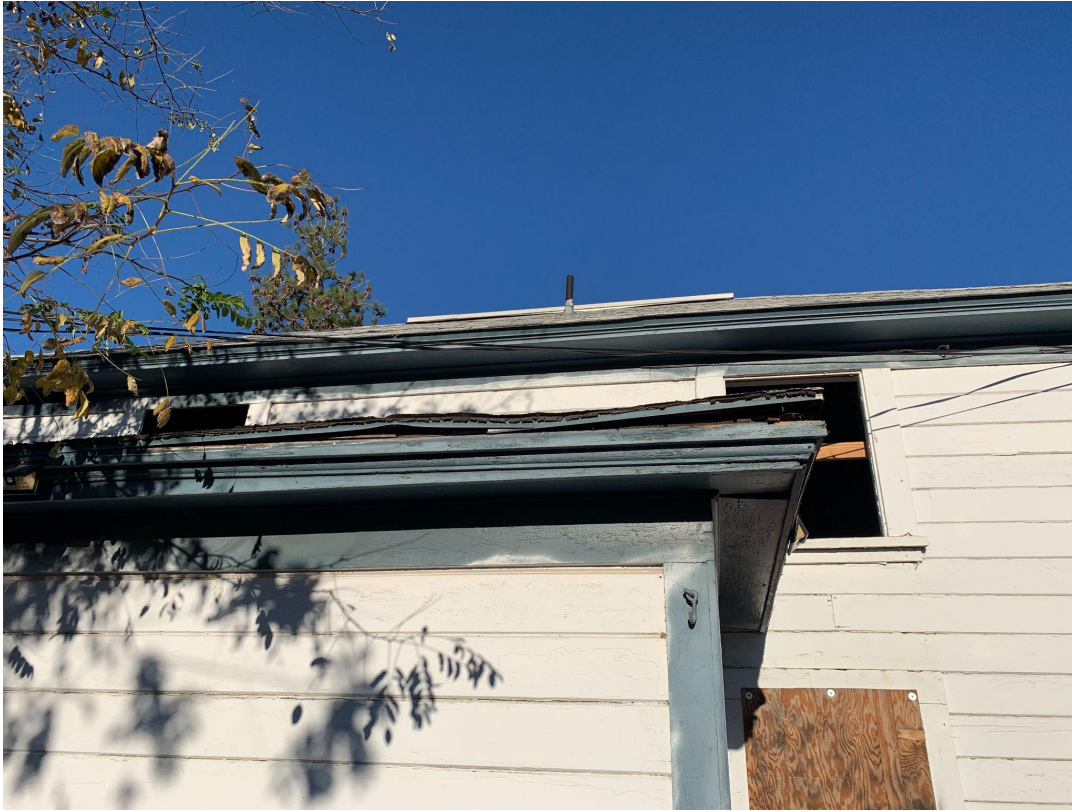
Figure 5. Entire roof has extensive dry rot, including the roof sheathing and roof rafters. High likelihood of collapse under any sort of load.

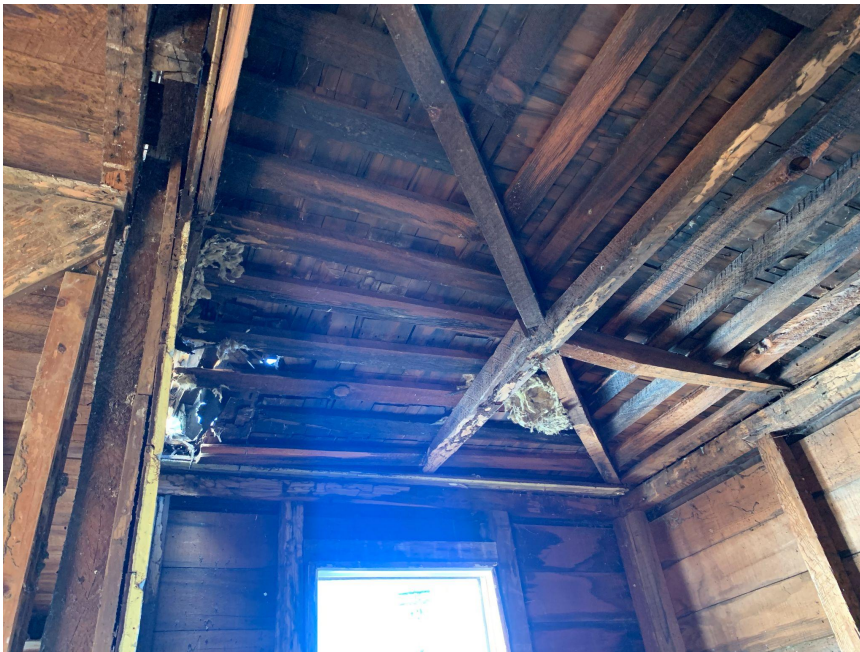
Figure 6. Note “Blackened” appearance on framing, this is evidence of extreme dry rot. Also note the limited framing support members and improper connection, all which increase likelihood of collapse.
